laser ablation cleaning, lacquer coats

## ABLATIVE LASER CLEANING OF LACQUER COATING

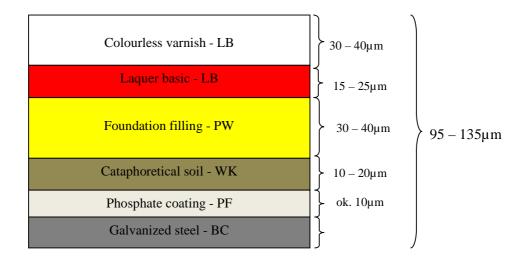
Fig. 1. The structure of productive lacquer coating system applied in the bodies of passenger cars

The surface of the elements of the bodies of motor vehicles is covered with a lacquer coating system built from many coats whose thickness varies between several to tens of micrometers (Fig. 1). The whole coating system is supposed to protect the body from external factors, e.g. mechanical abrasion or chemical and atmospheric factors, and it should also be decorative. Each of the coats in the lacquer system fulfils a separate function, for example, the phosphate and cataphoretic coats protect the elements of the body from corrosion, and the base lacquer and colourless lacquer protect from mechanical damage, and fulfil the decorative function. Unfortunately, the lacquer-coating system does not always fulfil its role. It is exposed to atmospheric factors (e.g. water, salt, temperature, solar radiation), as well as chemical and mechanical ones. Its damages are often too deep to protect the body from, for example, corrosion. In this case, removing the damaged section of the lacquer coat together with corrosion products is often the only solution. Usually, grinding with abrasive papers of various granulation and shape is used. However, grinding may cause side effects, e.g. environment pollution. Besides, the process is difficult to control, because it is impossible to remove the layer of the lacquer coat with exactitude to several micrometers. It is important to control the process with this exactitude, because of the following:

- the productive lacquer coat is 95-135µm (Fig. 1), or even 165µm thick, e.g. in Ferrari cars,
- it is not often necessary to remove all the layers of the lacquer coating (e.g. when only some of the coats were damaged or when we want only to improve decorative values),
- the material of the base should not become damaged in the process of removing the lacquer coat.

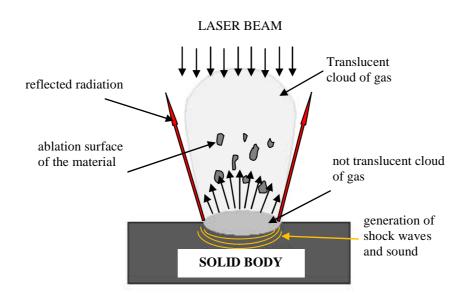
Fig. 2. The idea of ablation

The concept of the ablation process is presented in Fig. 2.

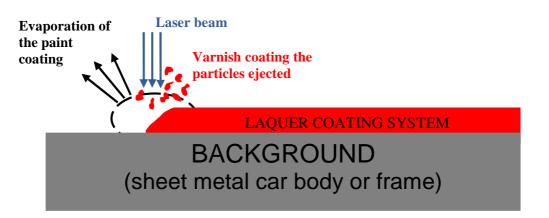
Fig. 3. The diagram of laser ablation applied to remove the lacquer coating system

In Fig. 3 there are presented the mechanism of removing lacquer coats with the beam of a Nd:YAG laser, which causes partial vaporisation of the lacquer coating under the influence of temperature, and also ejecting the remaining particles under the influence of the pressure wave, which leads to the exposure of the base.

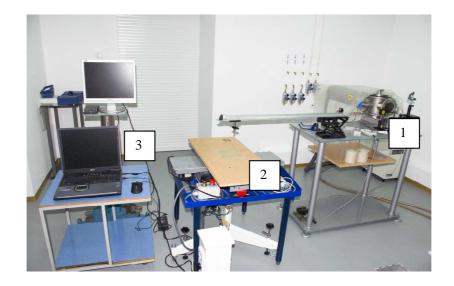
Fig. 4. The laser cleaning stand: 1 - Nd:YAG laser, 2 - measuring table, 3 - computer stand to steer the laser and measuring table

The pulsed Nd:YAG laser was used in preliminary laboratory investigations (max. 10Hz) with maximum impulse energy of 500mJ - Fig. 4.

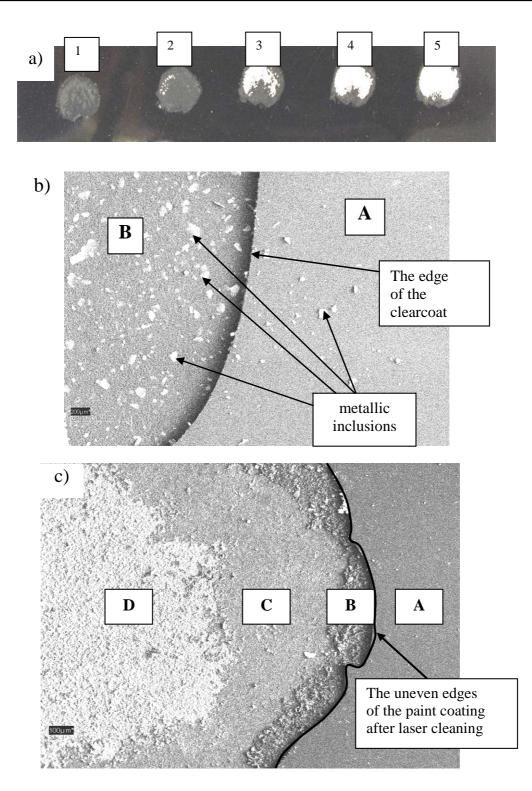
Fig. 5. The results of the experiment with the use of the Nd:YAG laser without the Galvo head – the removal of lacquer coating system under the influence of single impulses of the laser beam of the distribution similar to the Gaussian distribution; a) various variants of laser cleaning (1-5), b) lacquer coating system with the layer of colourless lacquer removed (Variant 2), c) lacquer coating system with uncovered various layers of the lacquer coat (Variant 4) - visible large non-homogeneity of the removal resulting from the distribution of the thickness of the laser beam power;
A - colourless lacquer, B - base lacquer with metallic filler (aluminium plates), C -filling foundation,
D - cataphoretic ground coat

The time of the radiation exposition did not exceed 25ns. The lacquer coating was removed as a result of ablation caused by a large power thickness in a short time (a dozen seconds) under the influence of a single impulse of the laser beam (Fig. 5a). Single impulses and uneven distribution of power thickness in the beam made it impossible to control the process, because one cannot foresee precisely the area on which the laser beam will operate (unless the technological mask is used). Another problem was to remove the exact thickness of lacquer coating needed. Moreover, there were uneven edges of the remaining coating after the selected area was removed (Figs. 5b, c), and zones of the lacquer coating system of various degrees of cleanness formed after using the laser beam, whose distribution was similar to a Gaussian distribution. The best distribution of a laser beam in the cleaning process is a rectangular one. Then, the whole zone where the laser beam operates is evenly cleaned.

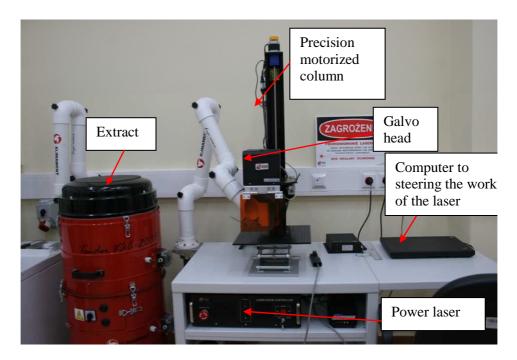
Fig. 6. The laser micro tooling stand consisting of a fibre laser, Galvo head, electrically steered precision column, ventilating fan, and a computer with specialist software to steer the work of the laser

The coating was cleaned with the beam of the Yb:YAG fibre laser with a Galvo head of the following parameters: the length of the radiation wave  $\lambda = 1064$ nm, exposition time 25ns, and repetition frequency 3÷500kHz (Fig. 6). Sixteen various parameters of the beam operation were applied. By regulating the power thickness of the laser beam, the repetition frequency, and the head scanning speed (Fig. 7), various cleaning effects of the coating were obtained.

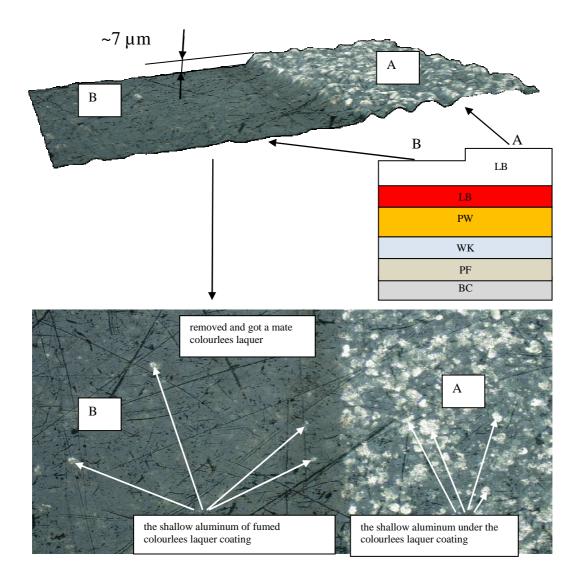
Fig. 8. The topography of the surface of the sample with the lacquer coating system taken from the car body after the laser beam operated on it, B - the zone after the laser beam operated on it, B - the zone after the laser beam operated on it - Variant 11 of laser micro-tooling from Fig. 4

The first analysed variant of the laser cleaning is the removal of several micrometers (approx.  $7\mu$ m) of the colourless lacquer, that is the upper layer of the lacquer coating (Fig. 8). Such removal of the lacquer is very necessary in the case of small scratching or fogging of the lacquer coat, that is the damage of the coat that frequently occurs during the

exploitation of the vehicle. In order to remove several micrometers of the surface layer, a larger thickness of the radiation power and much larger scanning speed of the laser beam than in the previous variant were applied. Due to the increased scanning speed, the material was not overheated, so its volume did not increase.

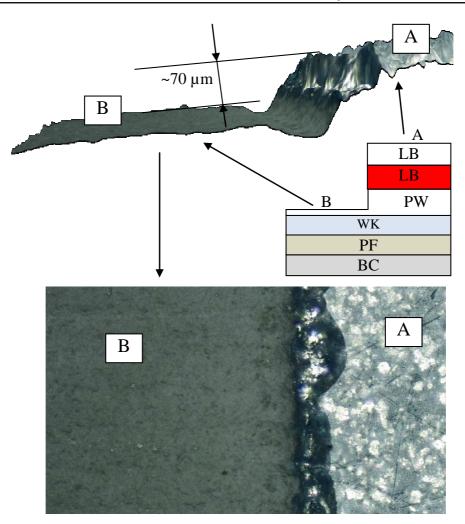
Fig. 9. The surface topography of the sample taken from the passenger car body with the lacquer coating system after the laser beam operated on it and approx. 70µm of the coat was removed- Variant 13 of laser micro-tooling from Fig. 4

In the other variant, the effects of cleaning two layers of the lacquer coating, that is the colourless lacquer and foundation lacquer with metallic filler (aluminium plates) are presented. As a result of pulsed laser radiation, the filling foundation was uncovered. This effect was obtained after scanning the surface with the laser beam five times with the same parameters as in the previous variant. Due to multiple scanning, approx.  $70\mu m$  of the lacquer coating was removed (Figs. 9, 10).

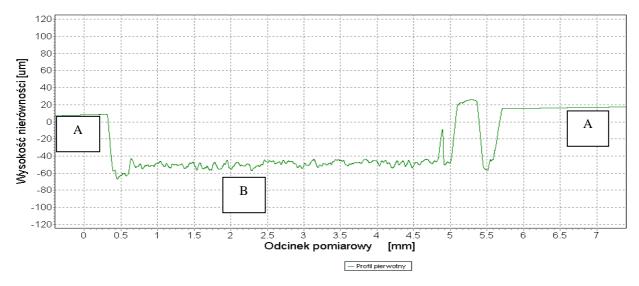
Fig. 10. The profilogram of the sample surface taken from the passenger car body with the lacquer coating after the laser beam operated on it and approx. 70µm of the coat was removed - Variant 13 of laser micro tooling (Fig. 4)
